→ Restoration  
of the palace  
facades, 2003-2008

Art of Conservation - Wilanów Palace Museum

## → Restoration of the palace façades, 2003-2008

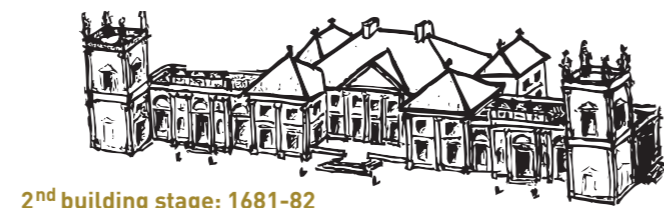
**Jan III Sobieski 1677-1696**  
Architect Augustyn Locci  
**1<sup>st</sup> building stage:**  
state around 1680

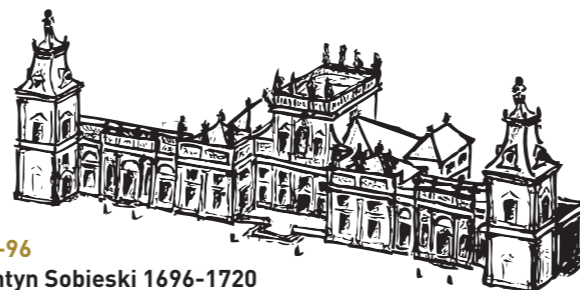
**2<sup>nd</sup> building stage: 1681-82**

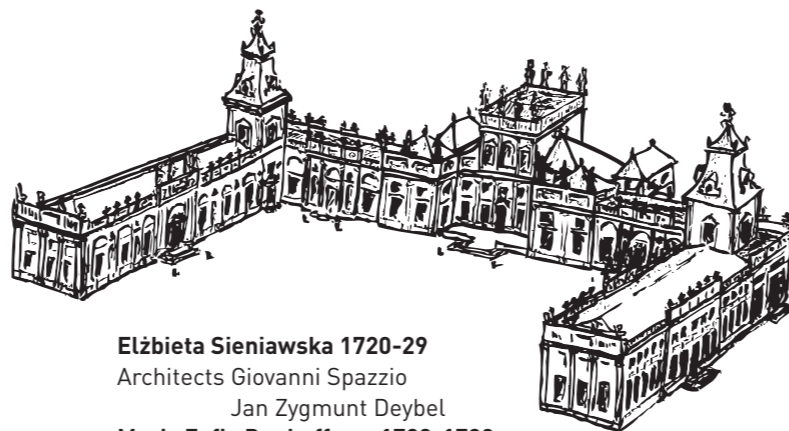
**3<sup>rd</sup> building stage: 1683-96**  
**Aleksander and Konstantyn Sobieski 1696-1720**
